# RIVER HABITAT AND MACROPHYTE SURVEYS IN THE HIGH TATRA MOUNTAINS OF SLOVAKIA AND POLAND

Results from 2010

A report by Paul Raven<sup>1</sup>, Nigel Holmes<sup>2</sup>, Hugh Dawson<sup>3</sup>, Agnieszka Ławniczak<sup>4</sup>,  
Eva Bulánková<sup>5</sup>, Jan Topercer<sup>6</sup> and Iga Lewin<sup>7</sup>.

March 2011

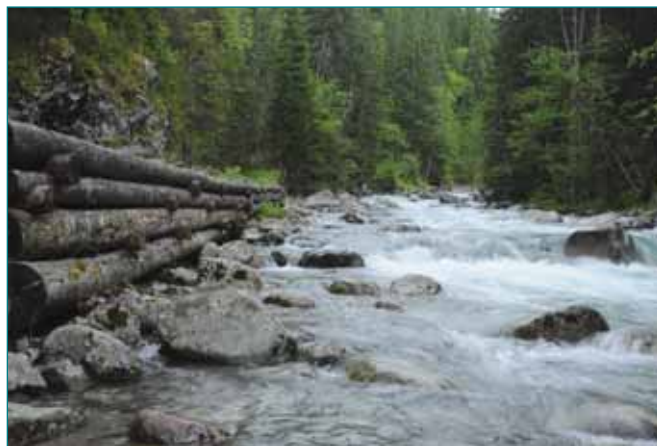
Artificial bank reinforcement and reprofiling produces a high HMS score.

**Habitat Modification Score (HMS)** is an indication of artificial modification to river channel morphology. To calculate the HMS for a site, points are allocated for the presence and extent of artificial features such as culverts and weirs and also modifications caused by the re-profiling and reinforcement of banks. Greater and more severe modifications result in a higher score. The cumulative

points total provides the Habitat Modification Score (HMS). A Habitat Modification Class (HMC) protocol has been developed which allocates the condition of the channel in a site to one of five modification classes, based on the total score (1 = near-natural; 5 = severely modified). In contrast to HQA, higher HMS scores reflect more artificial intervention and modification of the river channel within a site.

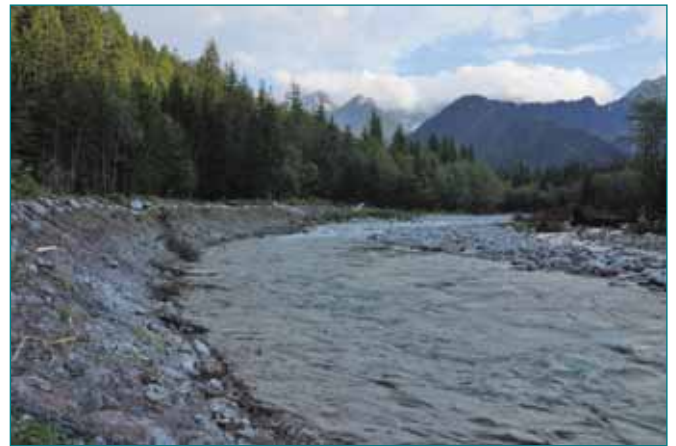
Re-profiled bank with wire basket gabions.

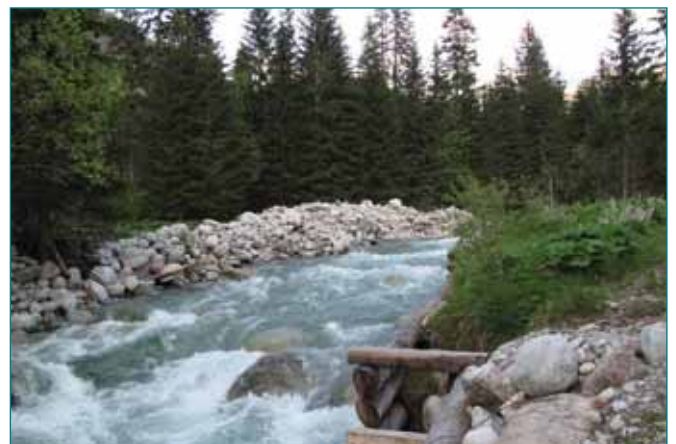
Boulders removed from the stream-bed.

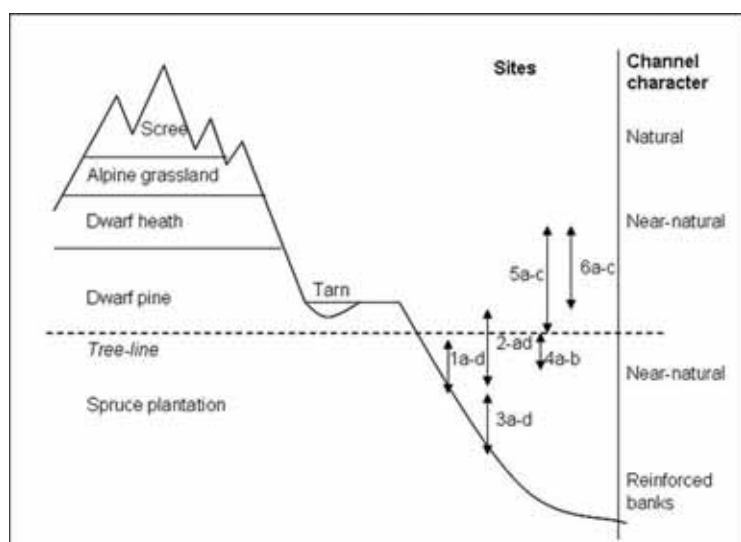
Figure 1. Schematic cross-section of the High Tatras, showing the position of our survey sites.

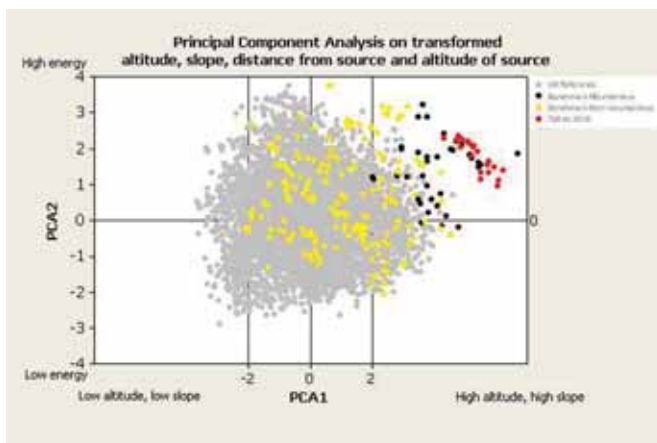
Figure 2. PCA plot, showing the Tatra sites (red) compared with high altitude (black), other benchmark sites (yellow) and the UK baseline survey sites (grey).

The European (CEN) guidance standard<sup>6</sup> on hydromorphological modification is based on a set of attributes and an associated scoring protocol that assess departure from near-natural conditions within a given reach. The attributes are scored on a 1-5 scale, with 1 representing near-natural conditions and 5 reflecting a severely modified state. A 1\* classification is achieved when the attribute is considered to be in pristine, or near-pristine condition. Some attributes are assessed quantitatively and others qualitatively (Annex J). Various sources of data derived from aerial photographs, maps and field surveys such as RHS can be used to score relevant attributes separately in a quantitative or semi-quantitative manner, with the overall score for a reach calculated using the best available information relevant for assessment purposes. This allows for broad comparisons of reaches along and between rivers to be made. For example, we previously compared the near-natural conditions of the Drawa River in north-west Poland with the River Itchen, a much more modified river of similar hydrological character in southern England<sup>20</sup>.

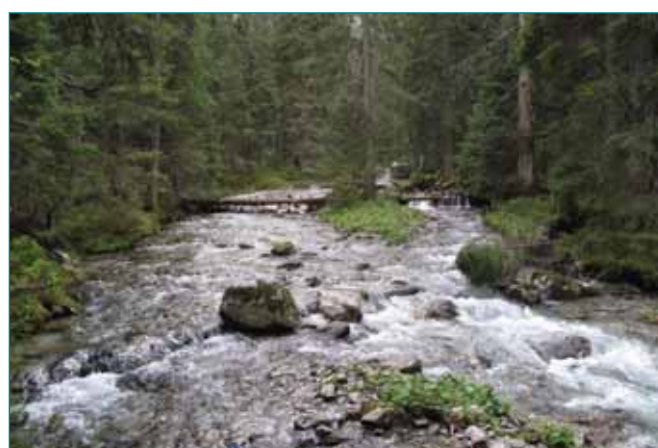
'Rapid-moderate' stream-flow, Biela voda.

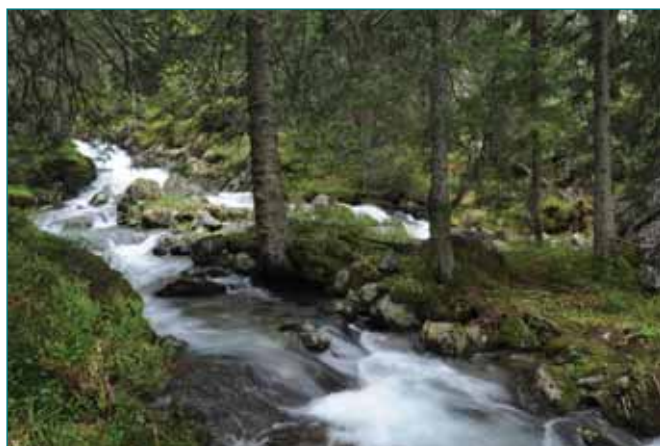
Mature island, Biela voda.

suggests that our High Tatra sites have more vegetated boulders, mid-channel bars and side bars than similar streams elsewhere (e.g. the Picos de Europa streams, where sediment supply is limited by the limestone nature of the geology<sup>18</sup>). There was also a higher occurrence of natural terraces and discrete sand deposits, with correspondingly fewer unvegetated side bars and marginal deadwater areas. This might appear surprising, but one possible explanation is that sufficient stability is provided by finer (gravel/sand) material that accumulates between or downstream of very large boulders and cobbles entering the channel from avalanches and rock-falls. Also, in prolonged dry periods in late summer the margins and in some cases entire lengths of headwater streams may occasionally dry out, allowing plants to colonise and stabilise the sediment.

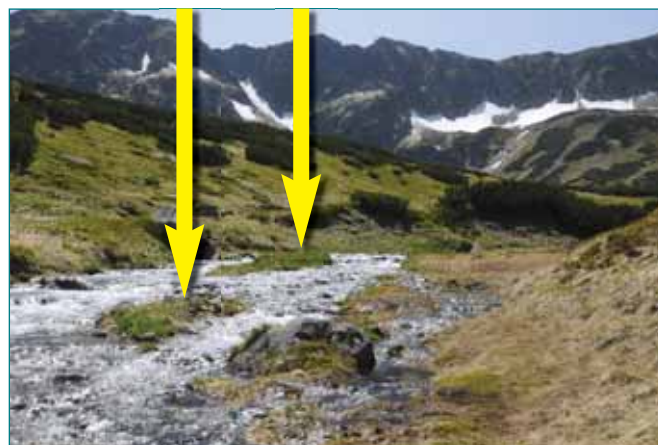
Vegetated mid-channel bars, tributary of the Potok Roztoka.

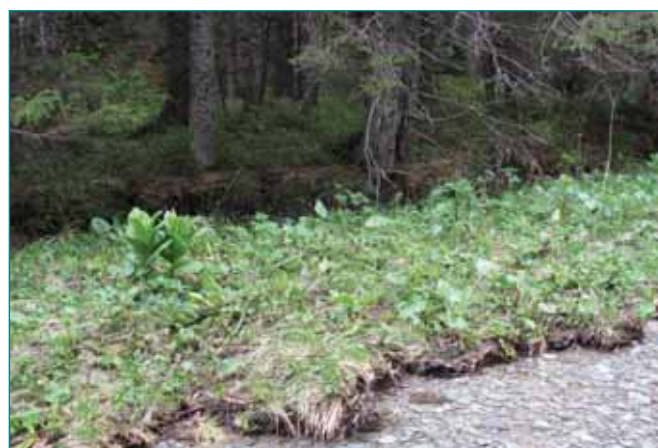
Natural berm/terrace formation, Biela voda.

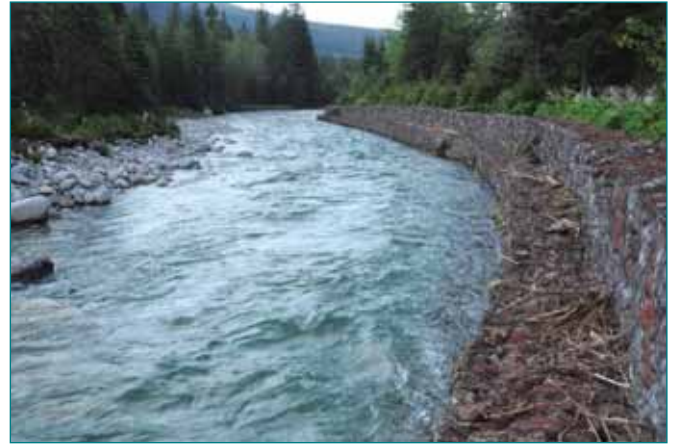
Bank reinforcement on the Biela voda downstream of our survey sites.

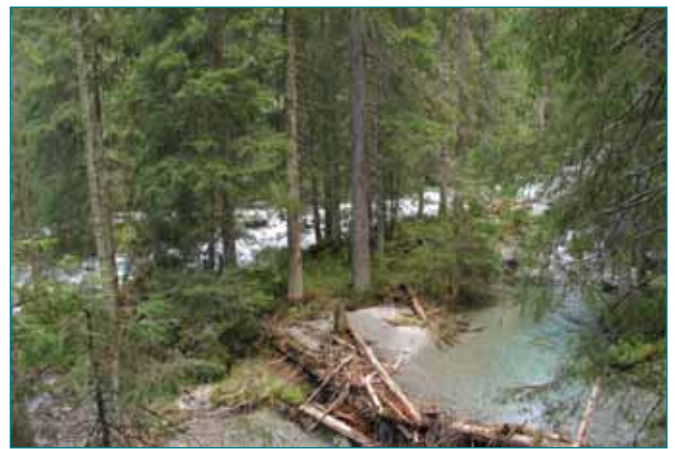
Local impoundment caused by a debris dam, Tatra 1c.

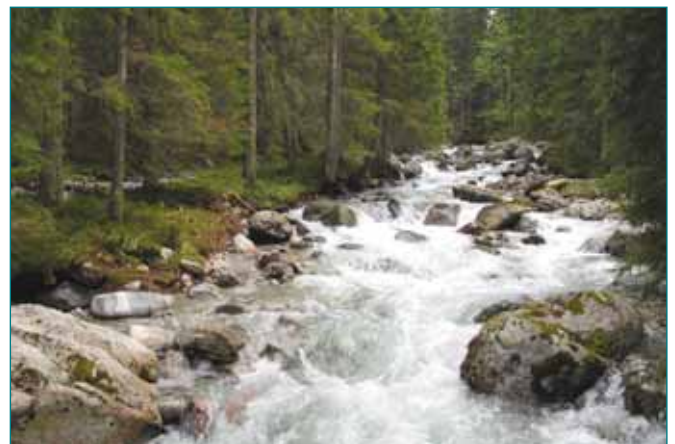
Mid-channel island, Tatra 1c.

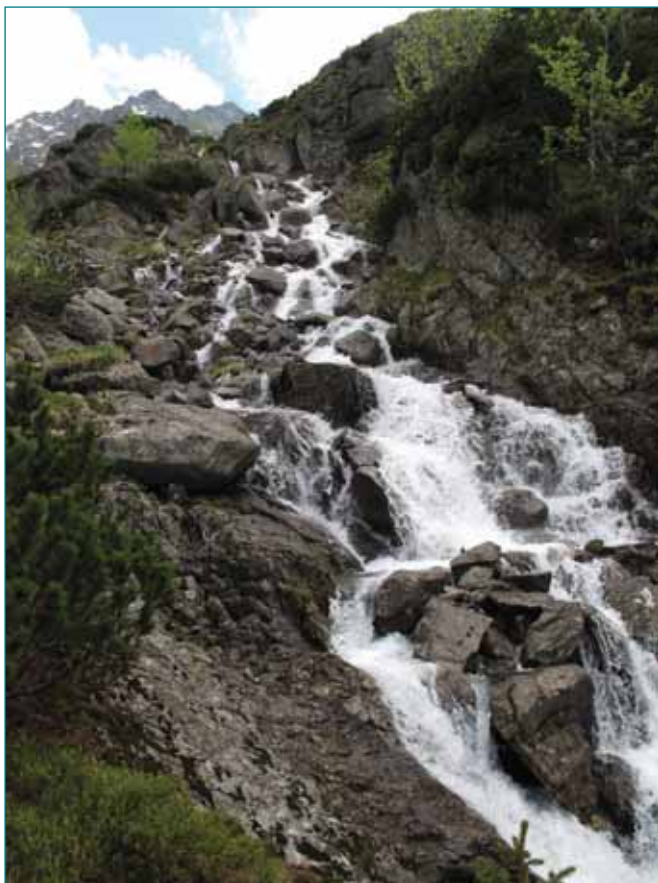
A bedrock chute, Litvorový potok, Tatra 2a.

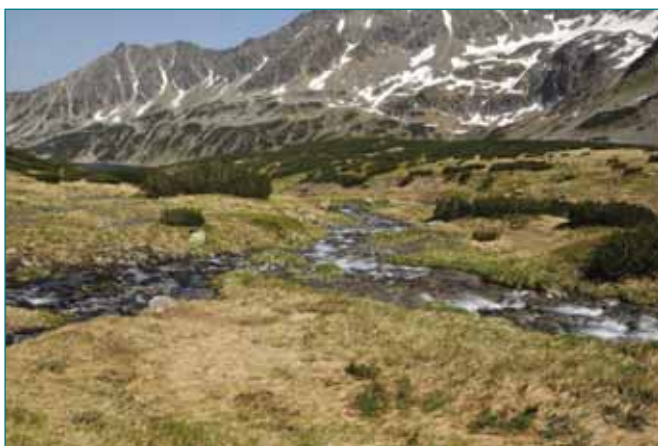
Stepped channel profile and moraine terraces, Tatra 6b.

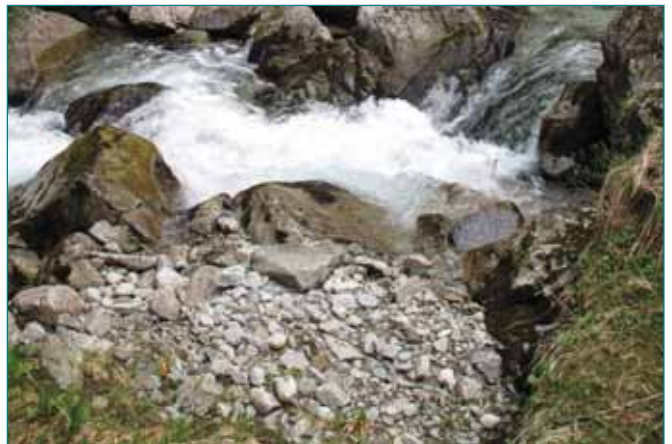
Discrete deposit in a small stream.

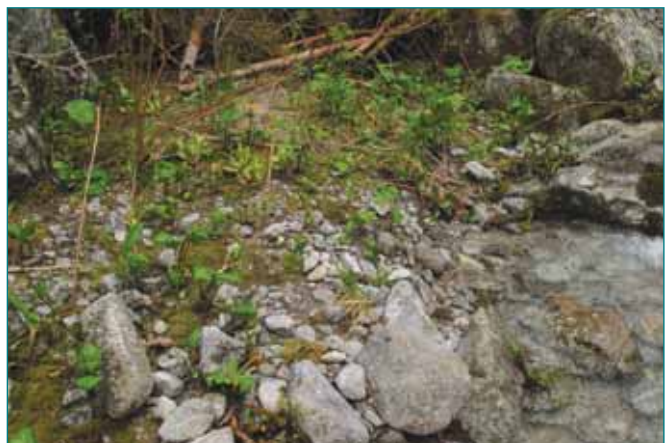
A vegetated discrete deposit.

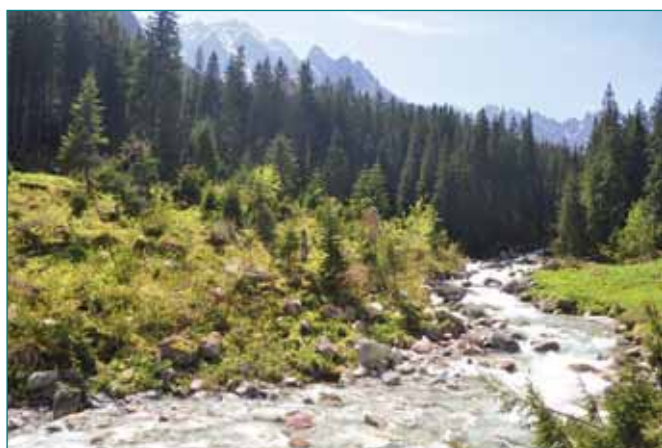
Re-naturalising plantation forest. See Table 6.

Forest structure and character	Proposed HQA score	
	Present	Extensive
Closed; even-aged. Dense trees, little light, no understorey.	0	0
Closed; even-aged. Thinned trees, sparse understorey.	0	0
Open; even-aged. <i>Vaccinium</i> understorey.	0	1
Open; even-aged. <i>Vaccinium</i> understorey, decaying fallen trees.	1	1
Open; multi-aged, patchy. <i>Vaccinium</i> understorey, fallen trunks, broadleaf trees present.	1	2
[Areas of unmanaged windthrow/bark beetle damage, patchy. Dead wood, broadleaf trees, tall herbs].	1	2
[Areas of avalanche/scree. Open. Dwarf pine and broadleaf species].	1	2
