A survey of building stone and roofing slate in Falkirk town centre

Open Report OR/13/015

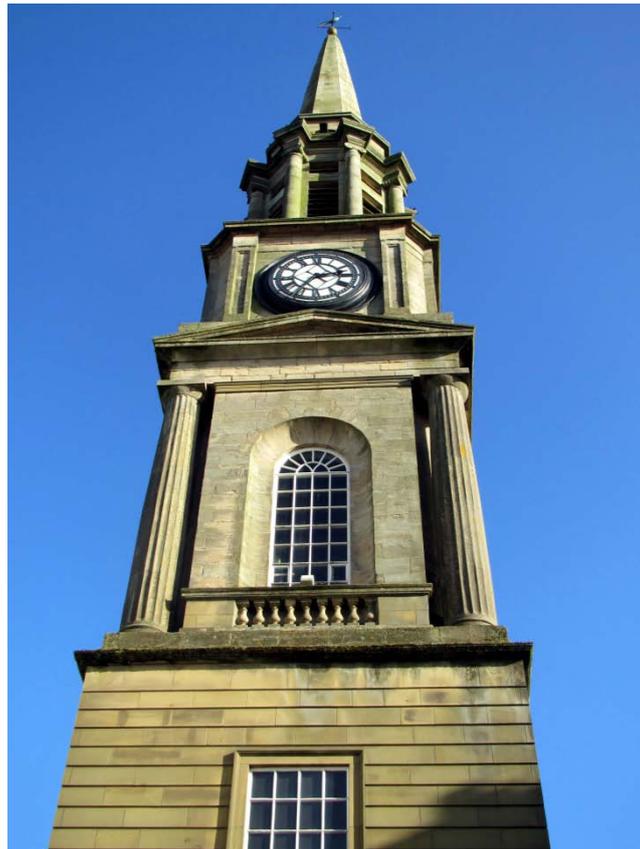
Front cover

The Steeple, Falkirk town centre. Original early 19th Century masonry of local Falkirk sandstone at middle levels. Lower levels clad in buff sandstone from northern England in late 20th Century. Spire reconstructed in unidentified sandstone in early 20th Century.

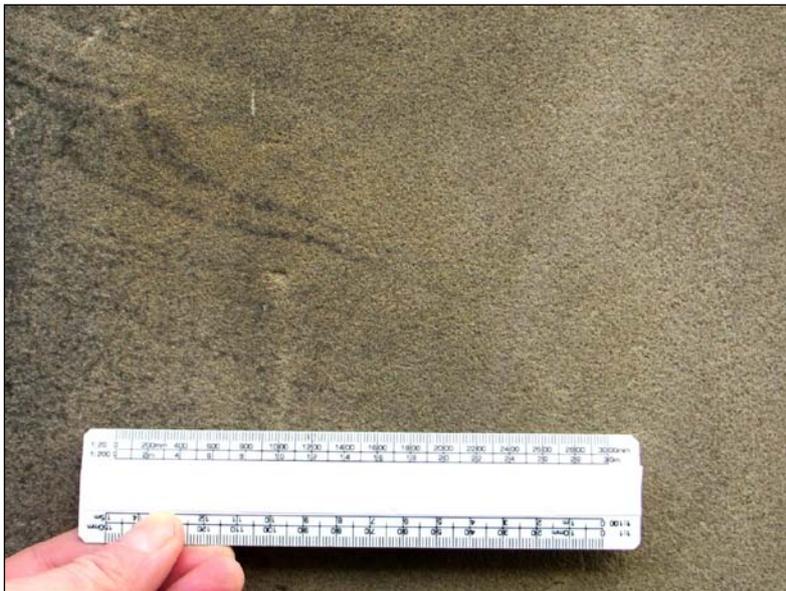
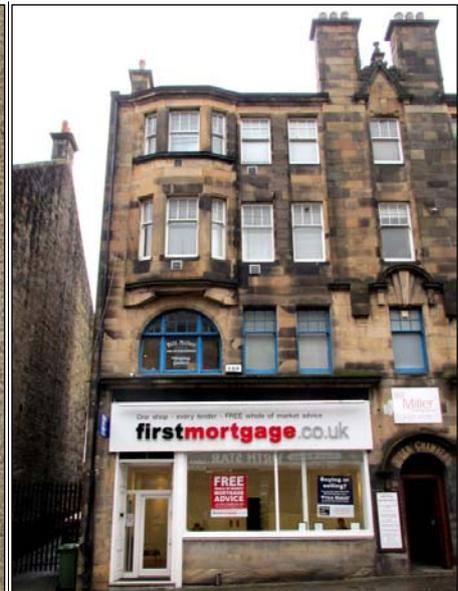
Stone code: SB2
Stone name: Buff sandstone 2
Reference building: Vicar Chambers, 27-35 Vicar Street
PRIMARY_KE 963213 & 963214
Colour of exposed surfaces: buff, with an orangeish to pinkish tinge locally
Grain-size: fine-sand-grade to medium-sand-grade
Primary sedimentary structure: most blocks are uniform; rare cross bedding; convoluted structure visible on surfaces of soiled/weathered blocks
Distinctive features: none, but this stone is rarely visible at ground level
Composition: impure
Comments: some blocks are gritty

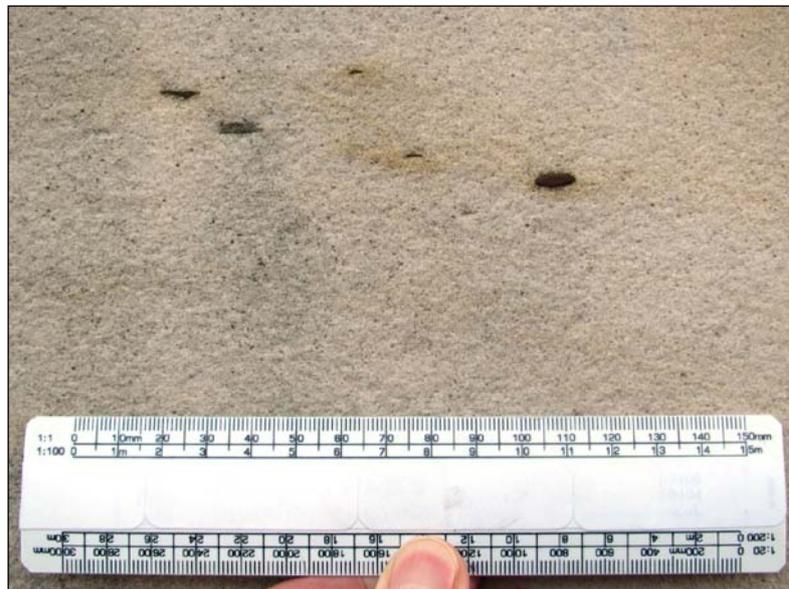
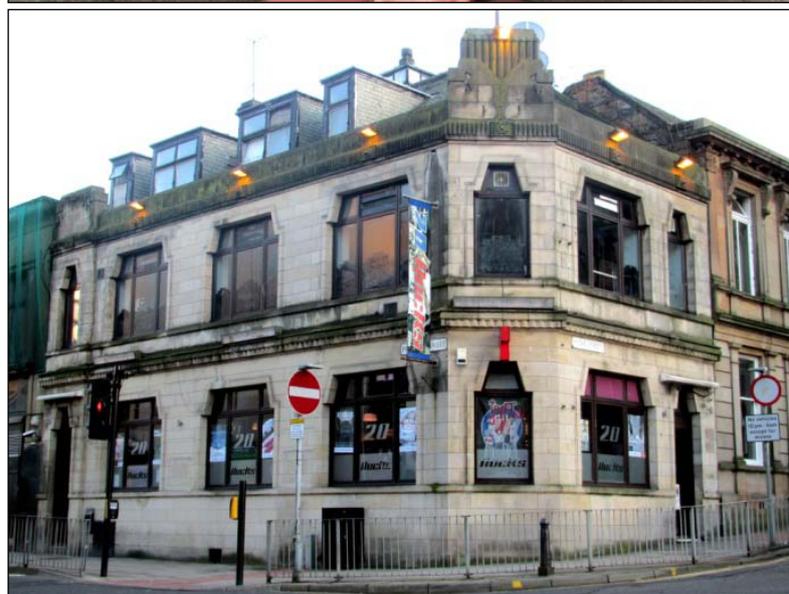
Stone code: SB3
Stone name: Buff sandstone 3
Reference building: 1 Princes Street
PRIMARY_KE 963222
Colour of exposed surfaces: light buff to very light buff (almost white)
Grain-size: fine-sand-grade to medium-sand-grade
Primary sedimentary structure: uniform
Distinctive features: scattered flakes of carbonaceous matter; faint Liesegang bands;
scattered brown mud flakes locally
Composition: relatively siliceous
Comments: weakly micaceous

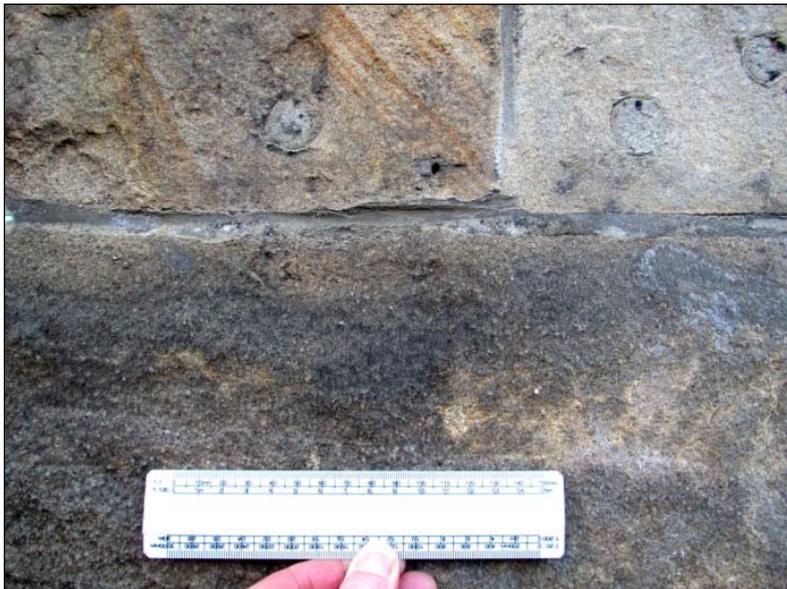
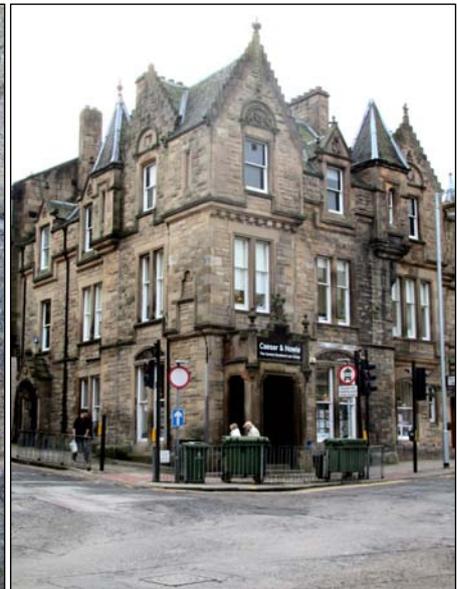
Stone code: SB4
Stone name: Buff sandstone 4
Reference building: 25-29 Newmarket Street
PRIMARY KE 963267 and 963266
Colour of exposed surfaces: light grey to light greyish buff
Grain-size: medium-sand-grade and coarse-sand-grade
Primary sedimentary structure: most blocks are uniform; parallel bedding developed locally; rare cross-bedding; rare lamination
Distinctive features: micaceous; scattered flakes of carbonaceous matter are usually present, and curved to sinuous leaf fragments up to 5 cm long may be present; can be gritty locally; brown iron nodules up to 2 cm across are developed locally; Liesegang bands can be developed locally
Composition: impure

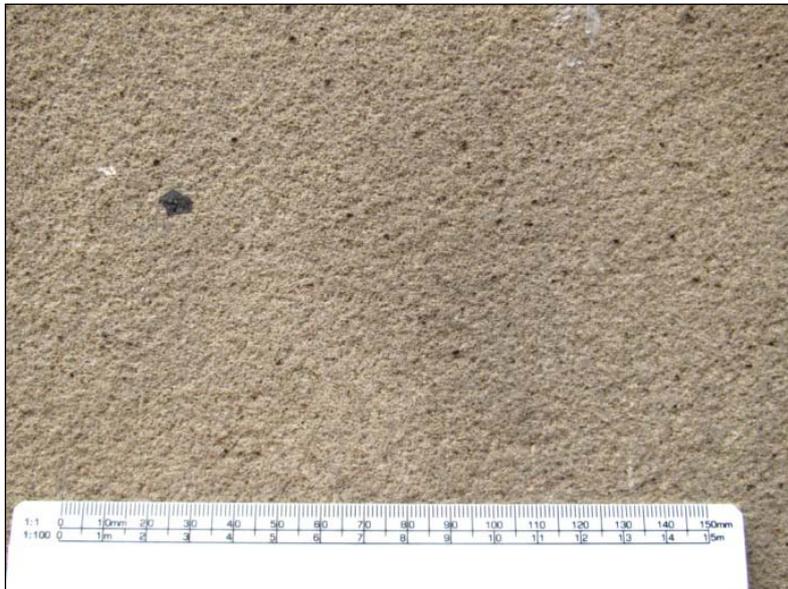
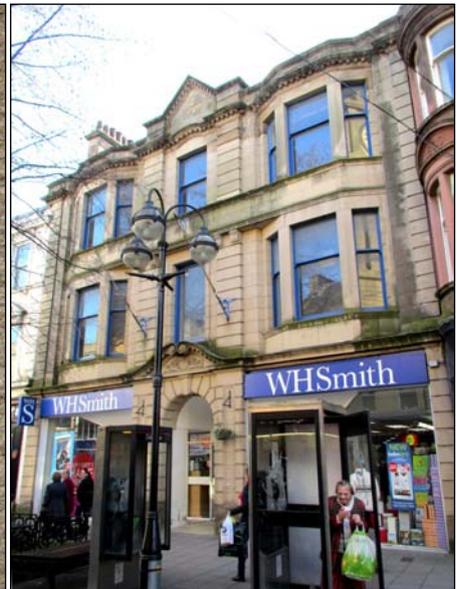
Stone code: SB5
Stone name: Buff sandstone 5
Reference building: 123-127 High Street (WH Smith)
PRIMARY_KE 961149
Colour of exposed surfaces: light brownish buff
Grain-size: medium-sand-grade to coarse-sand-grade; even grain-size
Primary sedimentary structure: essentially uniform; rare, faint hints of bedding
Distinctive features: strongly micaceous; rare fragments of carbonaceous matter up to 3 cm long; rare iron nodules up to 1 cm across; speckled character given by scattered, dark brown detrital grains up to 3 mm diameter
Composition: impure

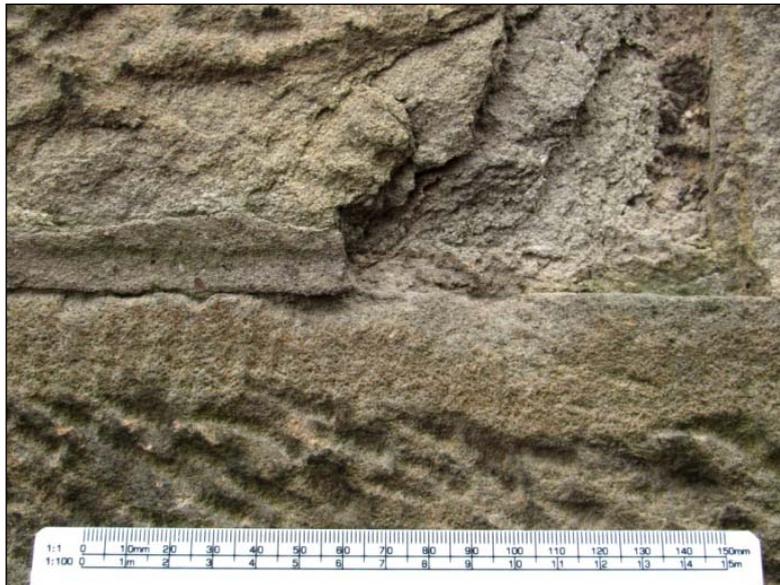
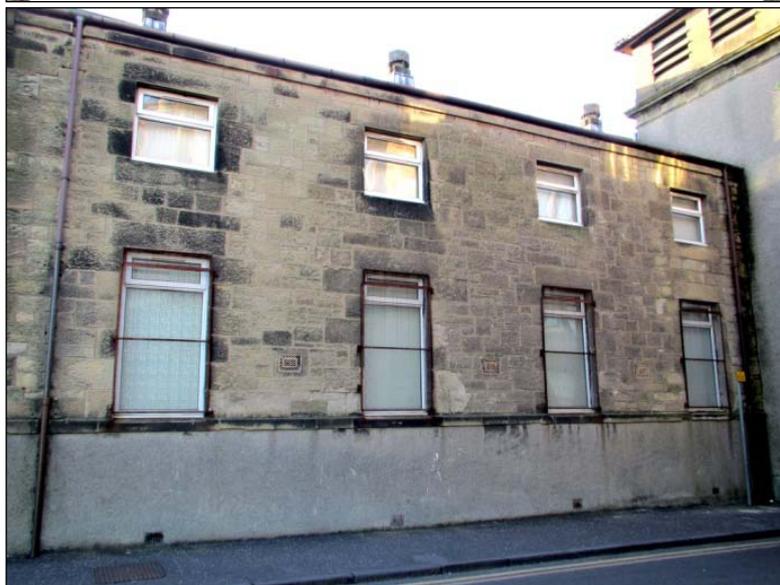
Stone code: SB6
Stone name: Buff sandstone 6
Reference building: 1 Mission Lane/9 Dundee Court (middle section of elevation facing Williamson Street)
PRIMARY_KE 961110
Colour of exposed surfaces: dull yellow
Grain-size: fine-sand-grade to medium-sand-grade; even grain-size
Primary sedimentary structure: mainly uniform; parallel bedding developed locally; cross bedding developed rarely
Distinctive features: micaceous
Composition: impure
Comments: stone appears to have a high clay content; studding conceals the primary sedimentary structure in many blocks; spalling extensively where face-bedded

- ‘Buff sandstone 6’ was recorded in only three buildings, two of which are adjacent on Manor Street. This is a relatively poor-quality building stone; the stone is spalling in places, particularly where blocks have been face-bedded. These buildings have no date panels, but their style and locations suggest they pre-date 1890.

This stone is characterised by a dull yellow colour, high clay content and generally uniform appearance. The stone was recorded in three buildings on Williamson Street and Manor Street. The stone is of relatively poor quality, and face-bedded masonry blocks are suffering from stone decay. The stone is likely to come from a relatively local source, probably one or more quarries in the Passage Formation or Scottish Lower Coal Measures Formation.

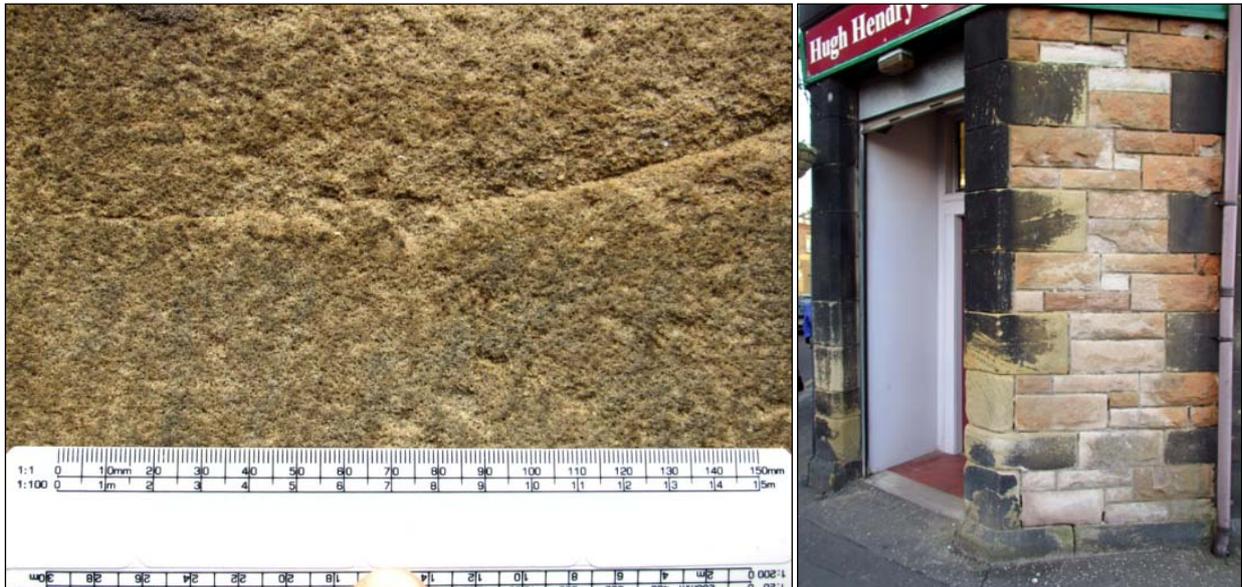
Stone code: SB7
Stone name: Buff sandstone 7
Reference building: dressings to tenement at 36-44 Melrose Place, Dundee Court
PRIMARY_KE 961203 & 961204
Colour of exposed surfaces: dull yellowish buff
Grain-size: coarse-sand-grade to very-coarse-sand-grade; locally gritty
Primary sedimentary structure: uniform, parallel bedded and cross-bedded
Distinctive features: locally micaceous; gritty
Composition: siliceous
Comments: this stone found only as dressings

The photograph at right is centred on the door of the tenement building in which SB7 forms the dressings (dull yellow blocks)

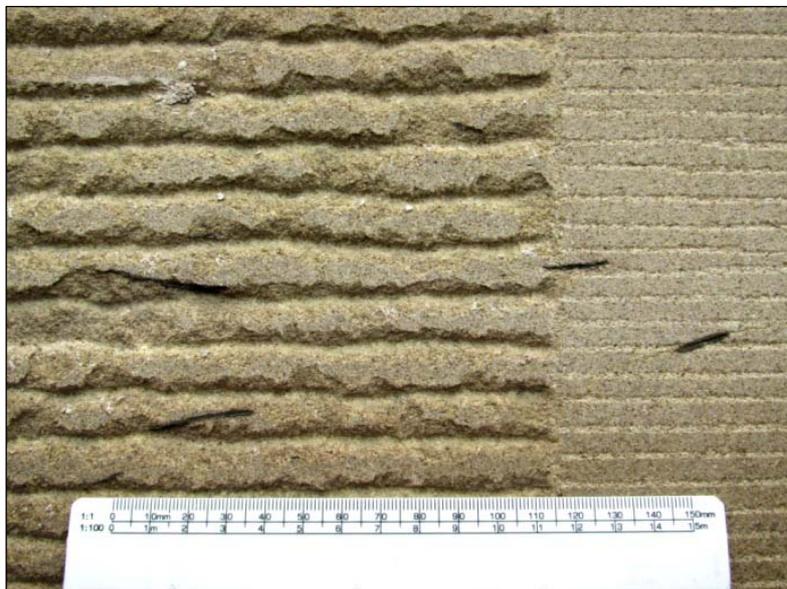
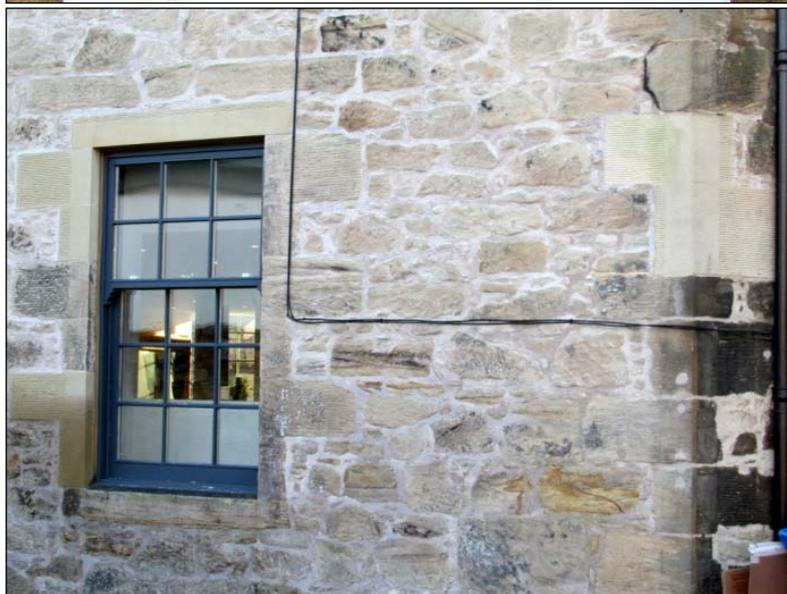
Stone code: SBM1
Stone name: Modern buff sandstone 1
Reference building: indents to Tattie Kirk, off Cow Wynd
PRIMARY_KE 961108
Colour of exposed surfaces: buff
Grain-size: fine-sand-grade to medium-sand-grade; even grain-size
Primary sedimentary structure: most blocks are uniform; faint bedding visible locally
Distinctive features: rare flakes of carbonaceous matter up to 5 cm long
Composition: impure
Comments: weakly to moderately micaceous

The photograph at bottom shows part of Tattie Kirk, where SBM1 forms indents to the window dressings and replacement quoins.

This sandstone is characterised by an even buff colour and uniform appearance. The stone has been recorded in four buildings; it has been used to make selective repairs (indents) to original masonry (e.g. in Tattie Kirk), and to construct a new shop front at ground floor level of the building at the north-west corner of Vicar Street and Lower Newmarket Street. Stanton Moor quarry in the Millstone Grit Group of Derbyshire (or another quarry in the same area that produced very similar stone) has been identified as the most likely source.

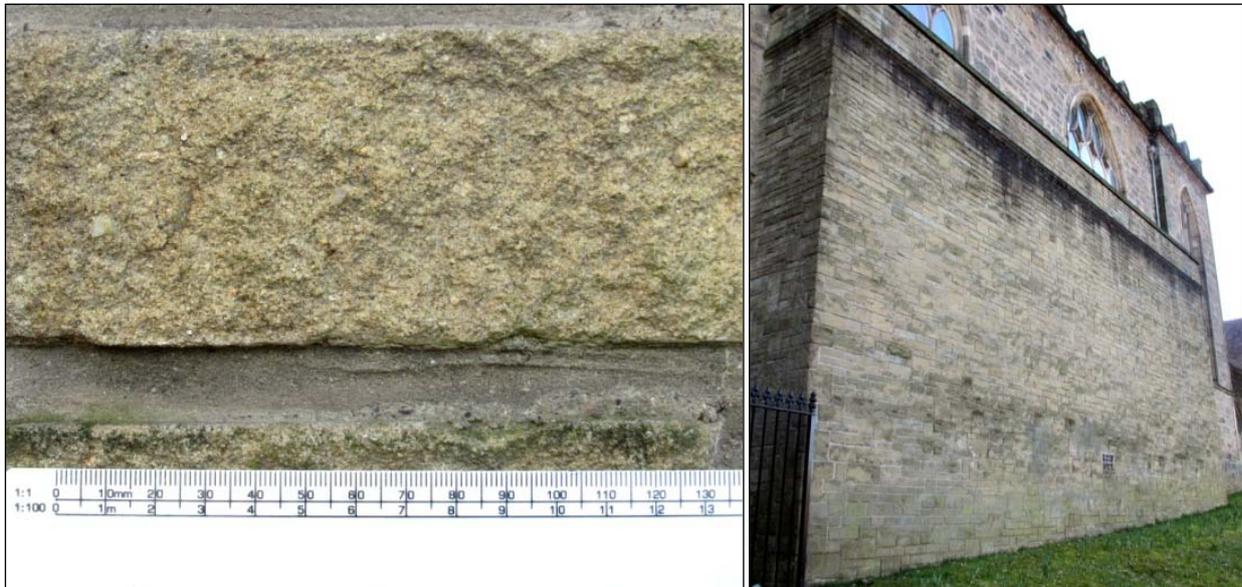
Stone code: SBM2
Stone name: Modern buff sandstone 2
Reference building: Fa' Kirk (Old Parish Church); also known as Falkirk Old and St Modans Church, Manse Place; elevation facing Newmarket Street
PRIMARY_KE 46333727
Colour of exposed surfaces: dull greyish buff
Grain-size: medium-sand-grade
Primary sedimentary structure: most blocks are uniform; faint bedding visible locally
Distinctive features: weakly gritty
Composition: impure

The photograph at right shows where SBM2 has been used to build a modern addition to the Newmarket Street elevation of Fa' Kirk.

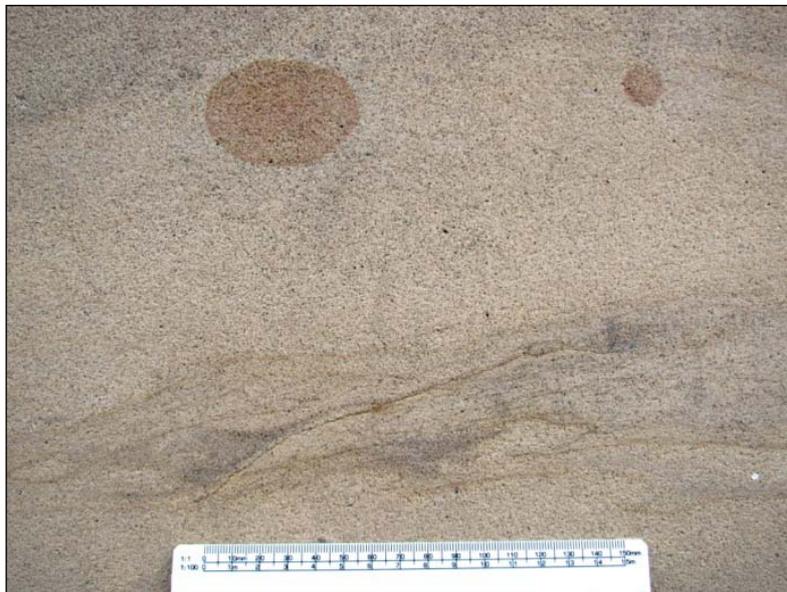
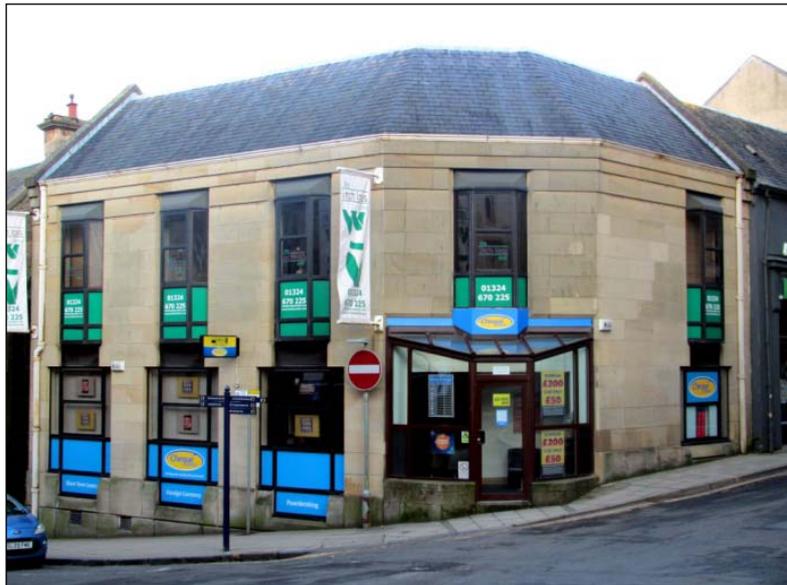
Stone code: SBM3
Stone name: Modern buff sandstone 3
Reference building: 3 Vicar Street
PRIMARY_KE 963224
Colour of exposed surfaces: buff
Grain-size: medium-sand-grade
Primary sedimentary structure: uniform
Distinctive features: flakes of carbonaceous matter, iron nodules and a gritty character are generally rare but common locally; Liesegang bands are developed locally; coloured spots up to 10 cm diameter are developed around small iron nodules
Composition: impure

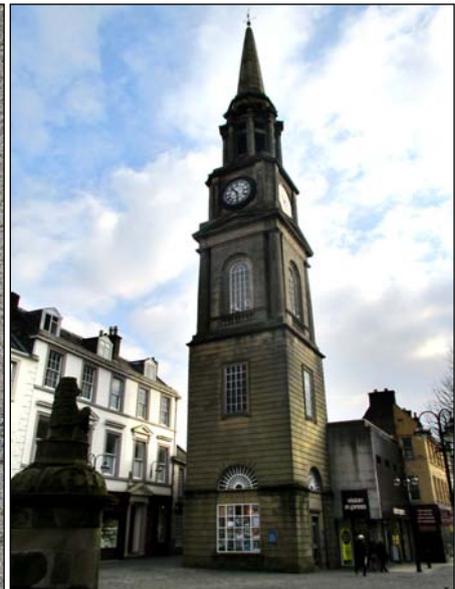
Stone code: SBM4
Stone name: Modern buff sandstone 4
Reference building: ground and lower floors of The Steeple, High Street
PRIMARY_KE 961318
Colour of exposed surfaces: buff
Grain-size: medium-sand-grade; even grain-size
Primary sedimentary structure: uniform (weakly aligned flakes of carbonaceous matter reveal the bedding orientation in some blocks)
Distinctive features: weakly micaceous; scarce flakes of carbonaceous matter are up to 2-3 cm long; nodules of hard brown iron up to 2 cm across are developed locally, with small iron-stained halos; rare fossil shell fragments are up to 8-9 cm long
Composition: impure
Comment: in 10 Newmarket Centre, (PRIMARY_KE 963303) this stone is fine-sand-grade

The ground and first floor levels of The Steeple are clad in SBM4.

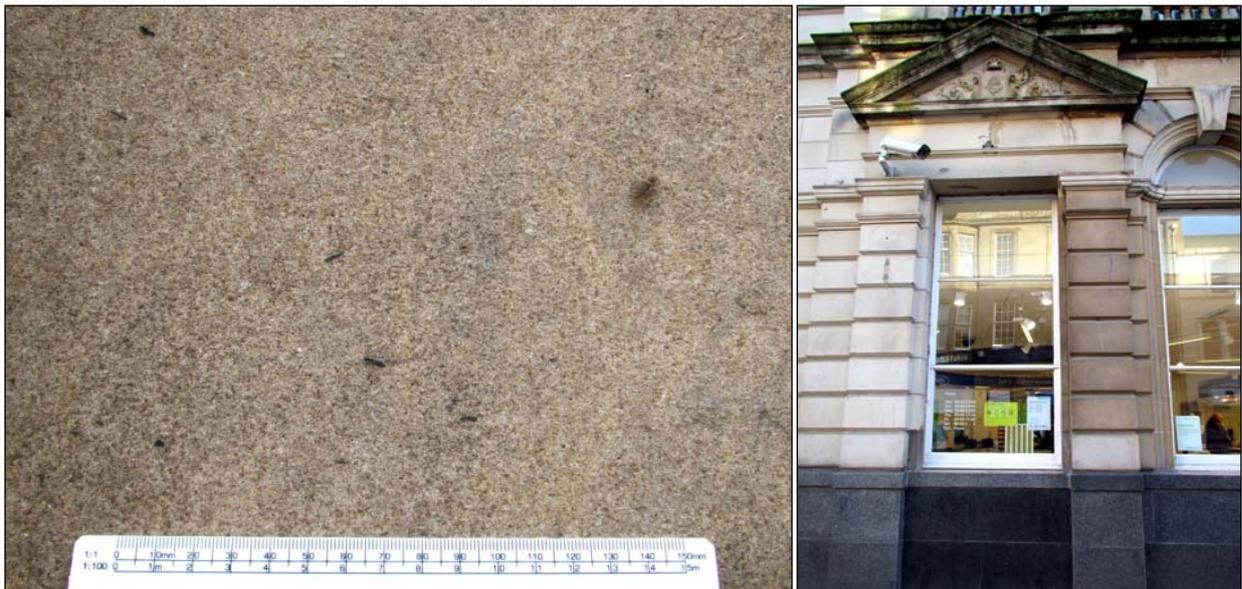
Stone code: SBM5
Stone name: Modern buff sandstone 5
Reference building: indents to Lloyds TSB, 137-139 High Street
PRIMARY_KE 961164
Colour of exposed surfaces: dark buff to buff
Grain-size: coarse-sand-grade; even grain-size
Primary sedimentary structure: essentially uniform; aligned flakes of carbonaceous matter and mica define the bedding orientation locally
Distinctive features: micaceous; scattered flakes up to 1 cm long and circles (leafs) up to 8 cm long of carbonaceous matter are common
Composition: impure

The photograph at right shows SBM5 indents to the right of the window.

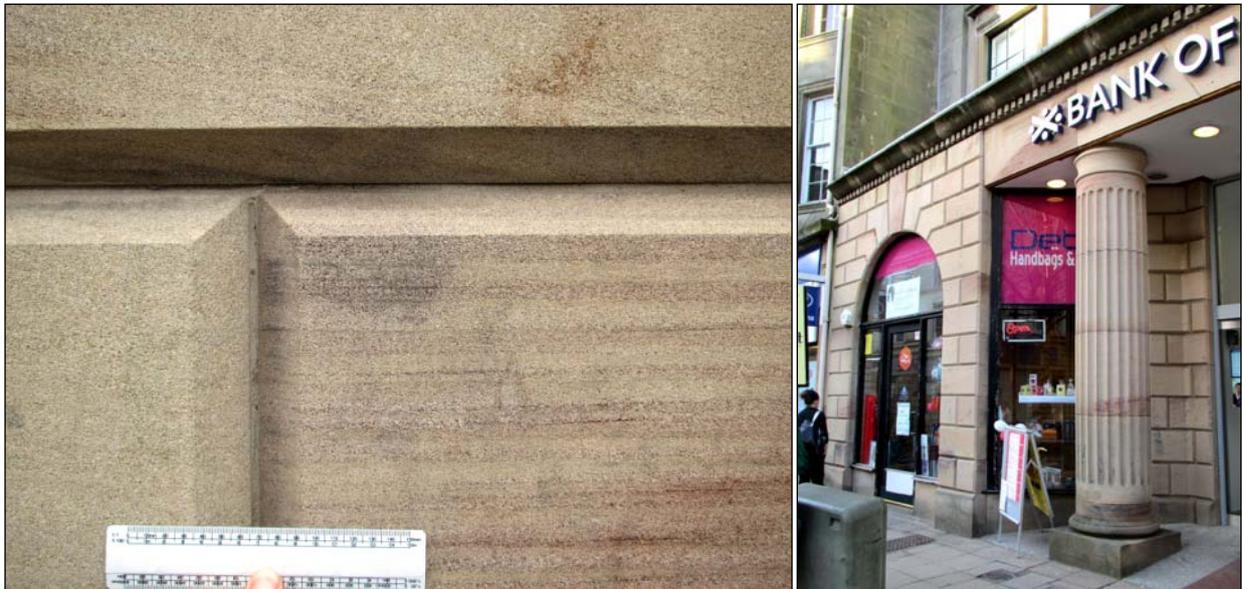
Stone code: SBM6
Stone name: Modern buff sandstone 6
Reference building: ground floor addition to 138-140 High Street
PRIMARY_KE 961316
Colour of exposed surfaces: buff
Grain-size: generally medium-sand-grade to coarse-sand-grade; locally granule-grade
Primary sedimentary structure: parallel bedding, cross-bedding, lamination and wispy lamination are all developed locally
Distinctive features: gritty character and Liesegang bands are developed locally
Composition: impure

The photograph at right shows the shop front addition to the Bank of Scotland building, which is made entirely of SBM6.

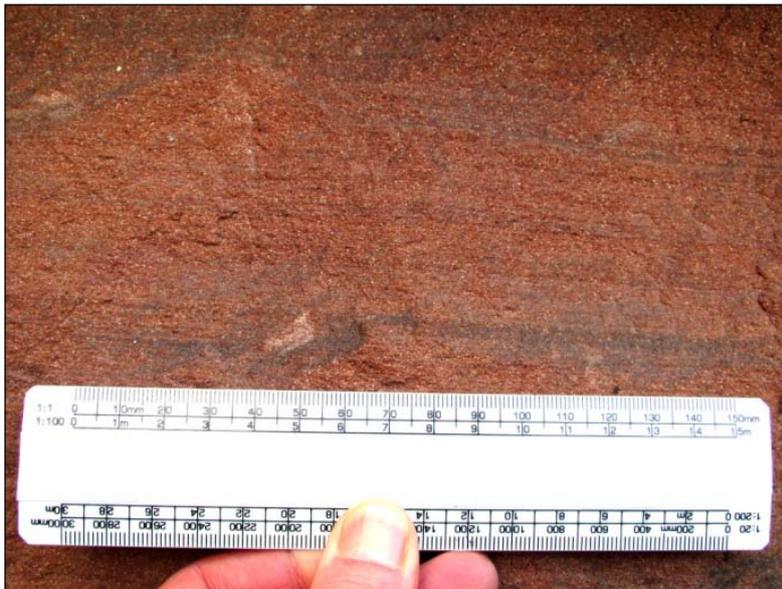
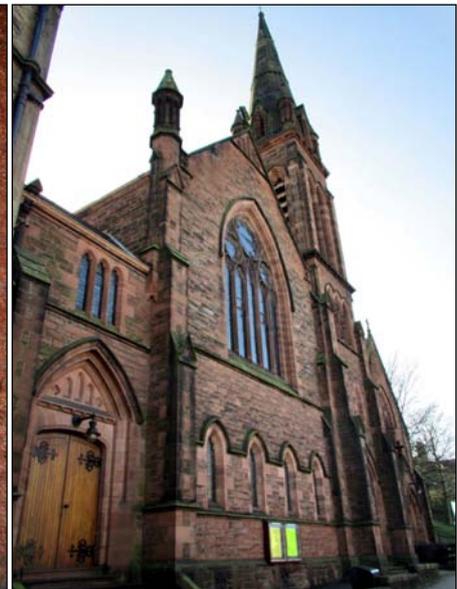
Stone code: SO1
Stone name: Orange sandstone 1
Reference building: St Andrew's West Church, Upper Newmarket Street
PRIMARY_KE 46333726
Colour of exposed surfaces: orange to pink
Grain-size: medium-sand-grade
Primary sedimentary structure: regular, parallel lamination; rare blocks show cross-bedding
Distinctive features: speckled character given by scattered grains of white feldspar; rare granulation seams; grey siliceous laminae
Composition: siliceous
Comments: very rare, hairline veins of calcite

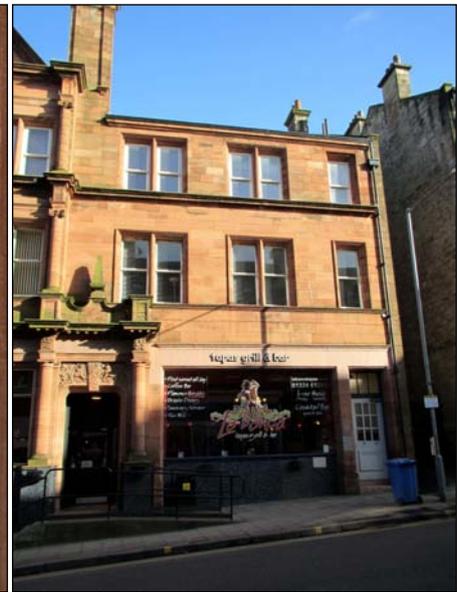
Stone code: SO2
Stone name: Orange sandstone 2
Reference building: 41-43 Vicar Street
PRIMARY_KE 963216 & 963217
Colour of exposed surfaces: orange
Grain-size: fine-sand-grade
Primary sedimentary structure: parallel bedding, cross-bedding and parallel lamination
Distinctive features: scattered shallow pits ~1 cm diameter, sometimes concentrated in bands
Composition: siliceous

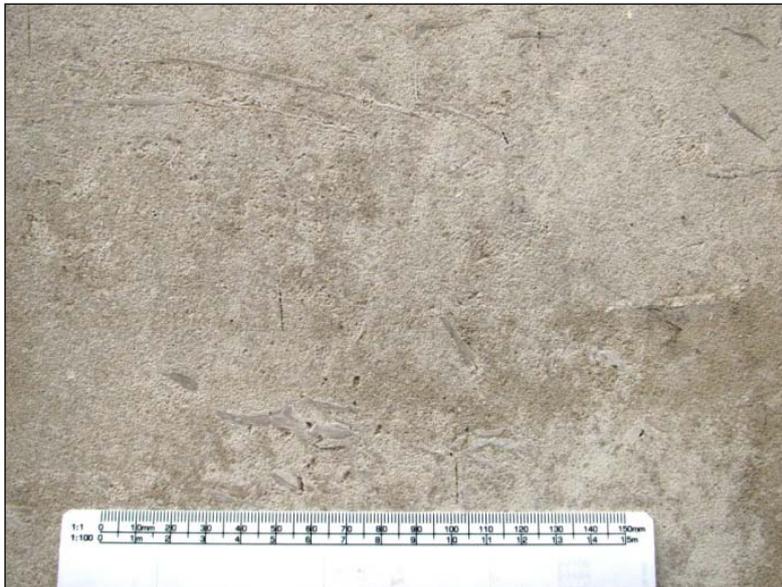
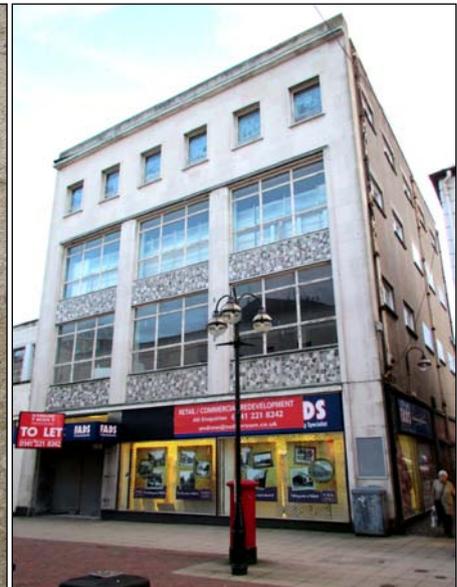
Stone code: L
Stone name: shelly limestone
Reference building: 165-169 High Street
PRIMARY_KE 961200
Colour of exposed surfaces: pale grey
Grain-size: fine-sand-grade to medium-sand-grade
Primary sedimentary structure: weak bedding defined locally by aligned shell fragments
Distinctive features: abundant shell fragments up to 10 cm long
Composition: shelly limestone

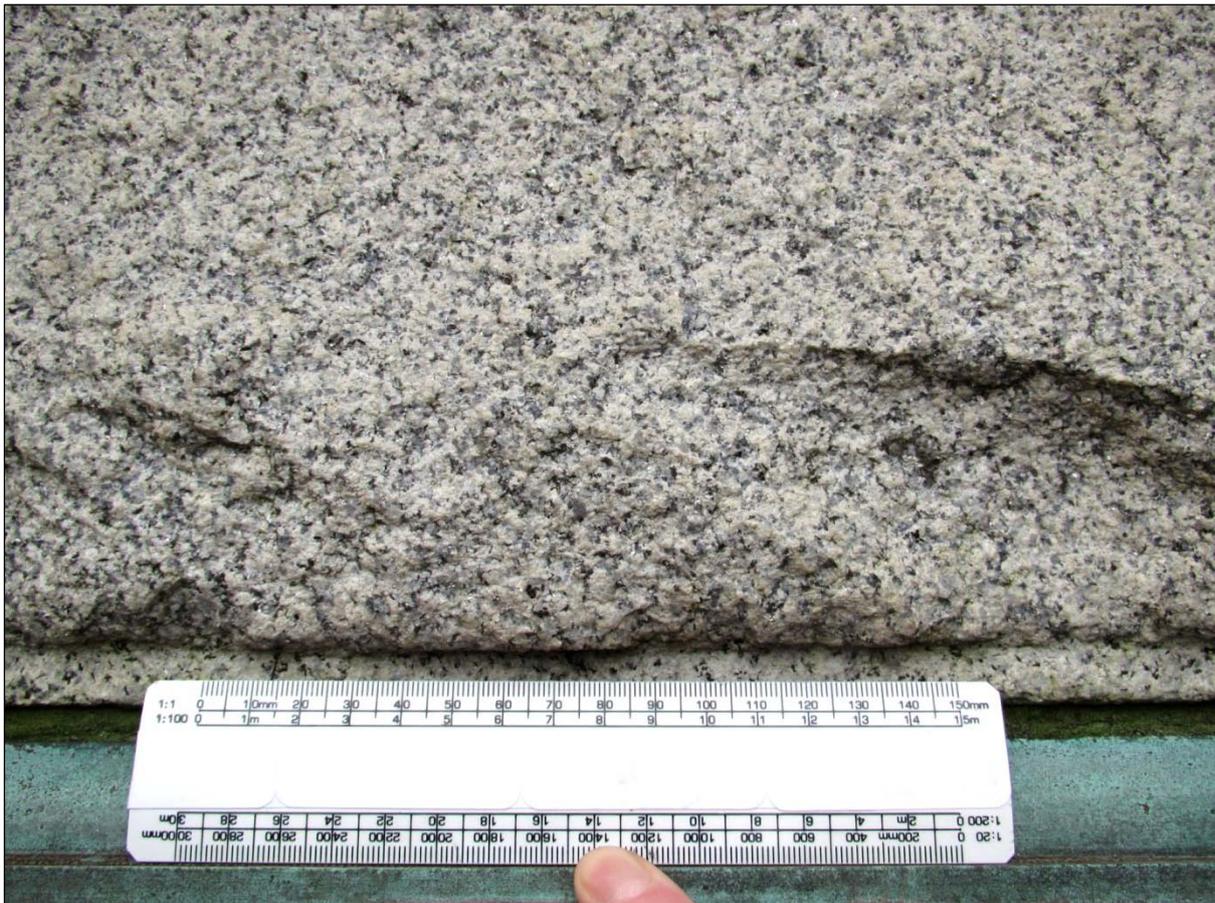
Stone code: G1
Stone name: Granite 1
Reference building: plinth of South African War Memorial, Newmarket Street
PRIMARY_KE 930773
Colour of exposed surfaces: very pale orangeish grey
Grain-size: coarse-crystalline (fine division)
Texture: equigranular; weakly foliated
Distinctive features: none
Composition: muscovite-biotite granite

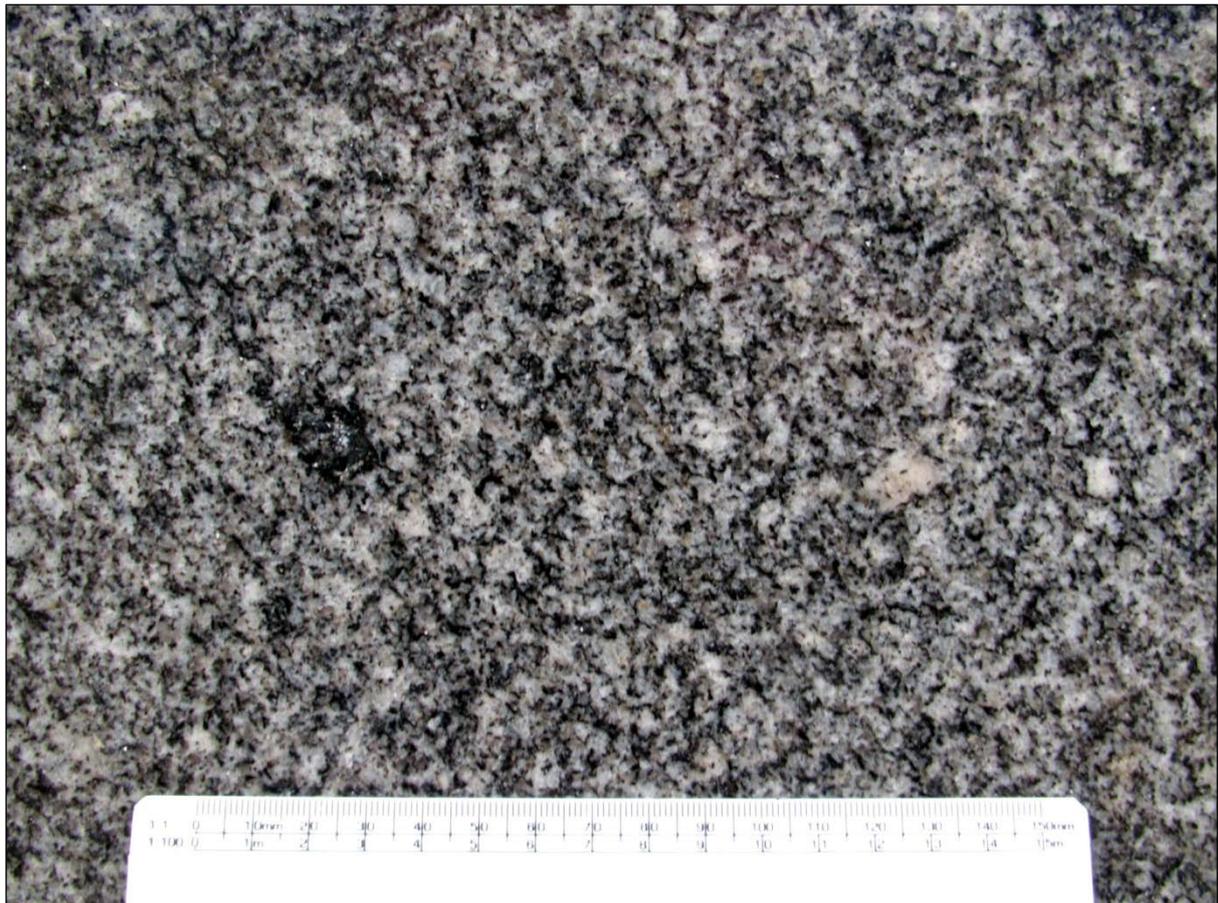
Stone code: G2
Stone name: Granite 2
Reference building: base course of 137-139 High Street
PRIMARY_KE 961164
Colour of exposed surfaces: dark grey
Grain-size: coarse crystalline (fine to medium division)
Texture: largely equigranular but weakly inequigranular (feldspar-phyric) in places; foliated
Distinctive features: micaceous; scattered black patches (mafic enclaves) up to 5 cm across
Composition: biotite-rich granodiorite

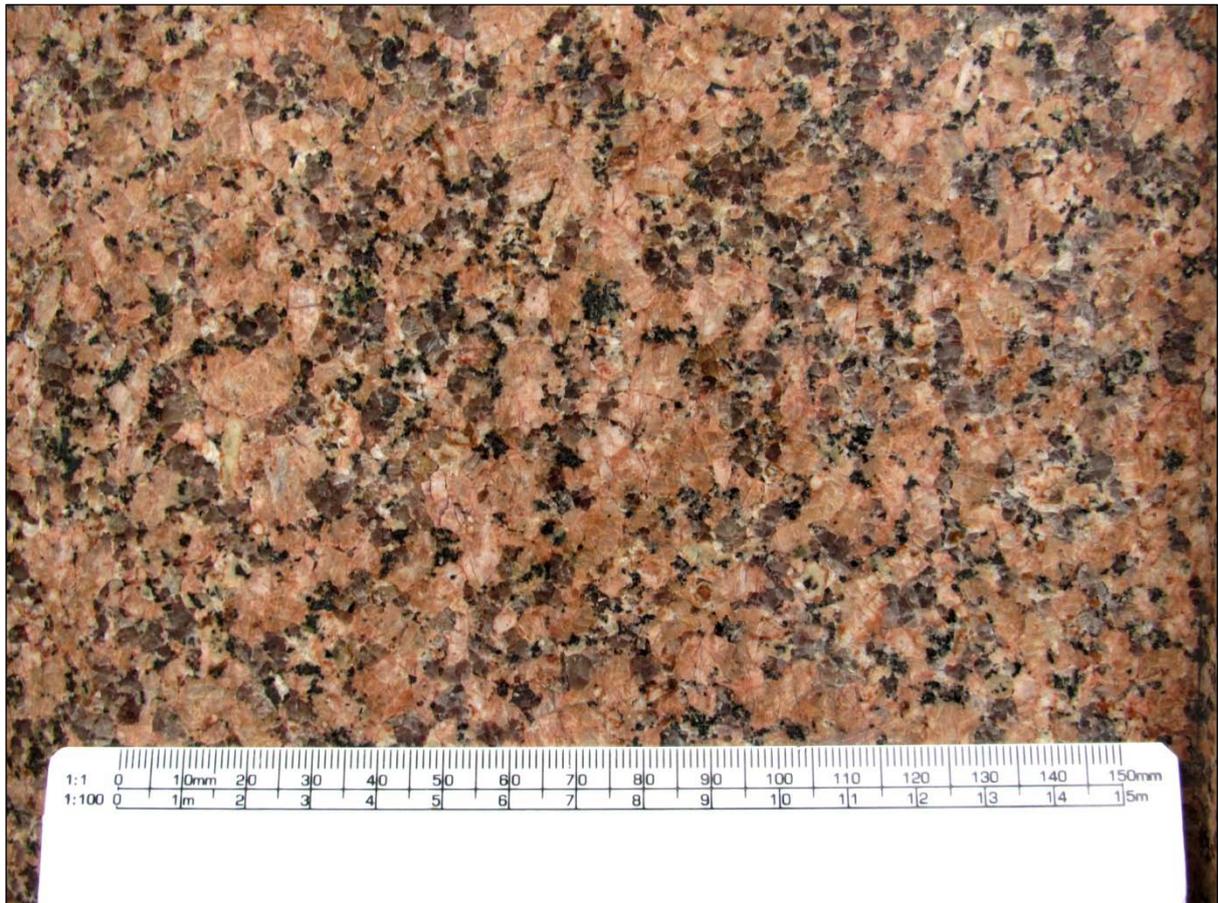
Stone code: G3
Stone name: Granite 3
Reference building: base course 134-136 High Street
PRIMARY_KE 961315 & 961350
Colour of exposed surfaces: greyish pink
Grain-size: coarse-crystalline (medium to coarse division)
Texture: inequigranular (weakly feldspar-phyric); massive
Distinctive features: rare dark patches (mafic enclaves) are up to 3 cm across
Composition: biotite granite

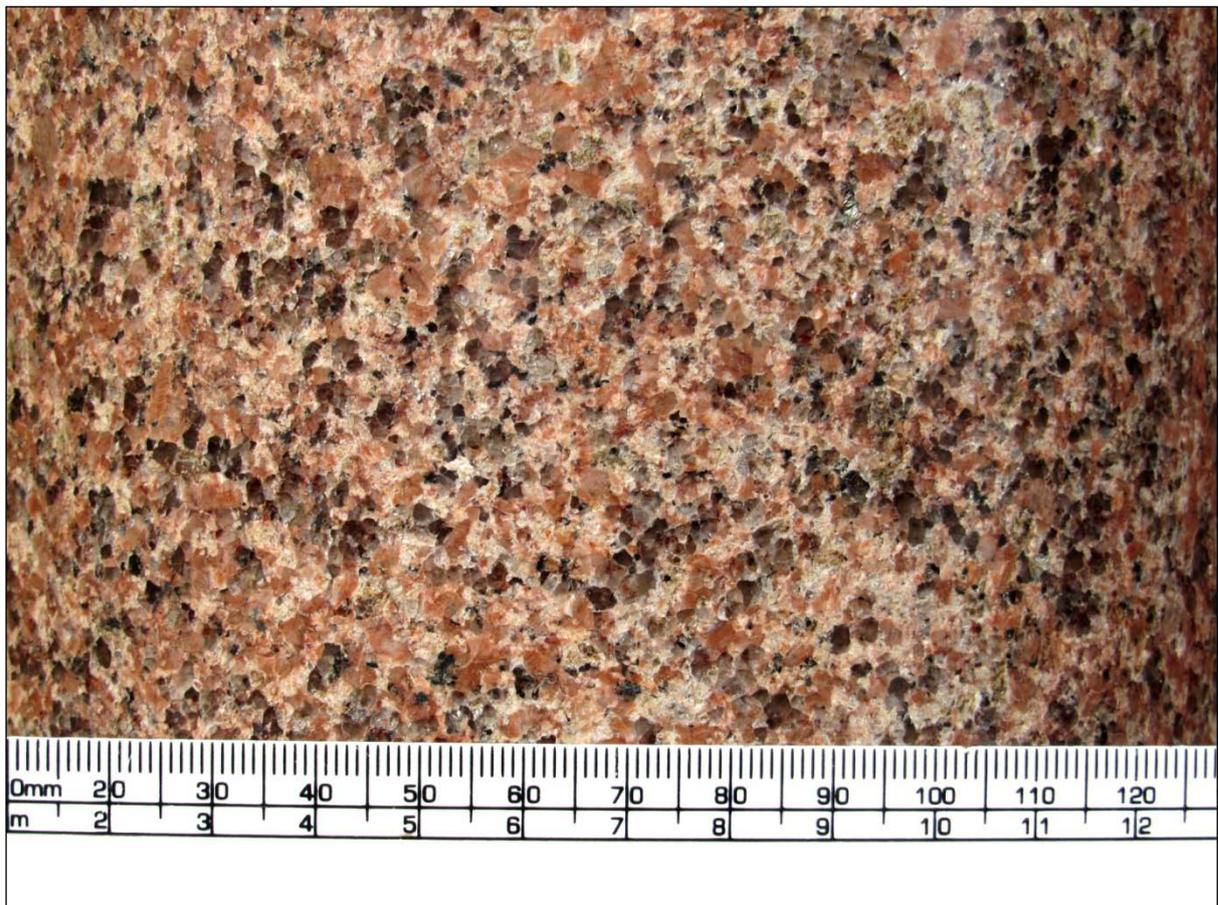
Stone code: G4
Stone name: Granite 4
Reference building: columns in main door arch, 12-14 Newmarket Street
PRIMARY_KE 963306
Colour of exposed surfaces: brownish pink
Grain-size: coarse-crystalline (medium division)
Texture: equigranular; massive
Distinctive features: none
Composition: biotite granite

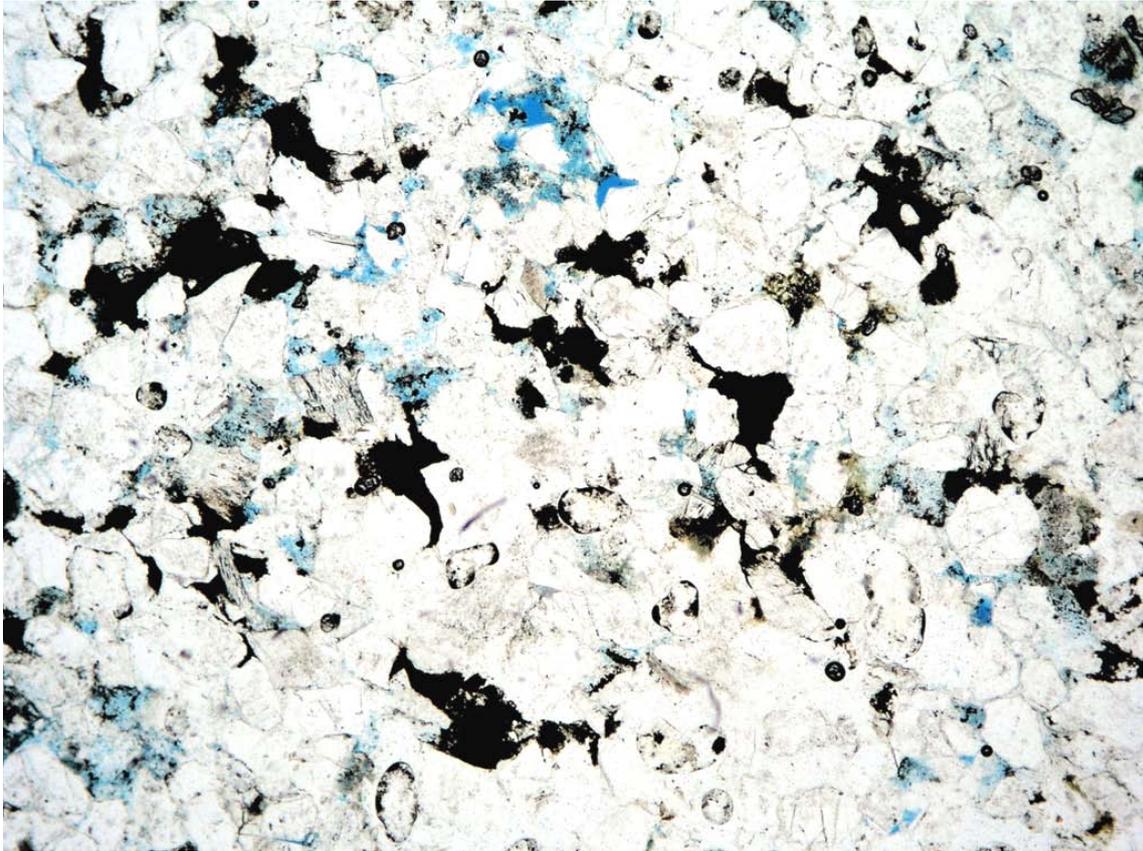
- 1) The sample consists of a small chip from the internal walling of The Steeple, at third floor level.
- 2) Faint laminae are formed by accumulations of iron oxide minerals and mica flakes.
- 3) Orange-brown speckles up to 1.5 mm across are composed mainly of iron oxide.
- 4) The carbonate mineral is iron-bearing (ferroan dolomite, ankerite or siderite)
- 5) A substantial proportion of the space between detrital grains is infilled by clay.
- 6) The stone shows parallel lamination, with hints of possible cross-lamination or 'wispy bedding'.

Figure A6_3. Two images of sample ED11049-1, as it appears in thin section. White grains are mainly quartz. Black areas are mainly iron oxide minerals. Pore spaces appear blue. The field of view is 3.3 mm wide.

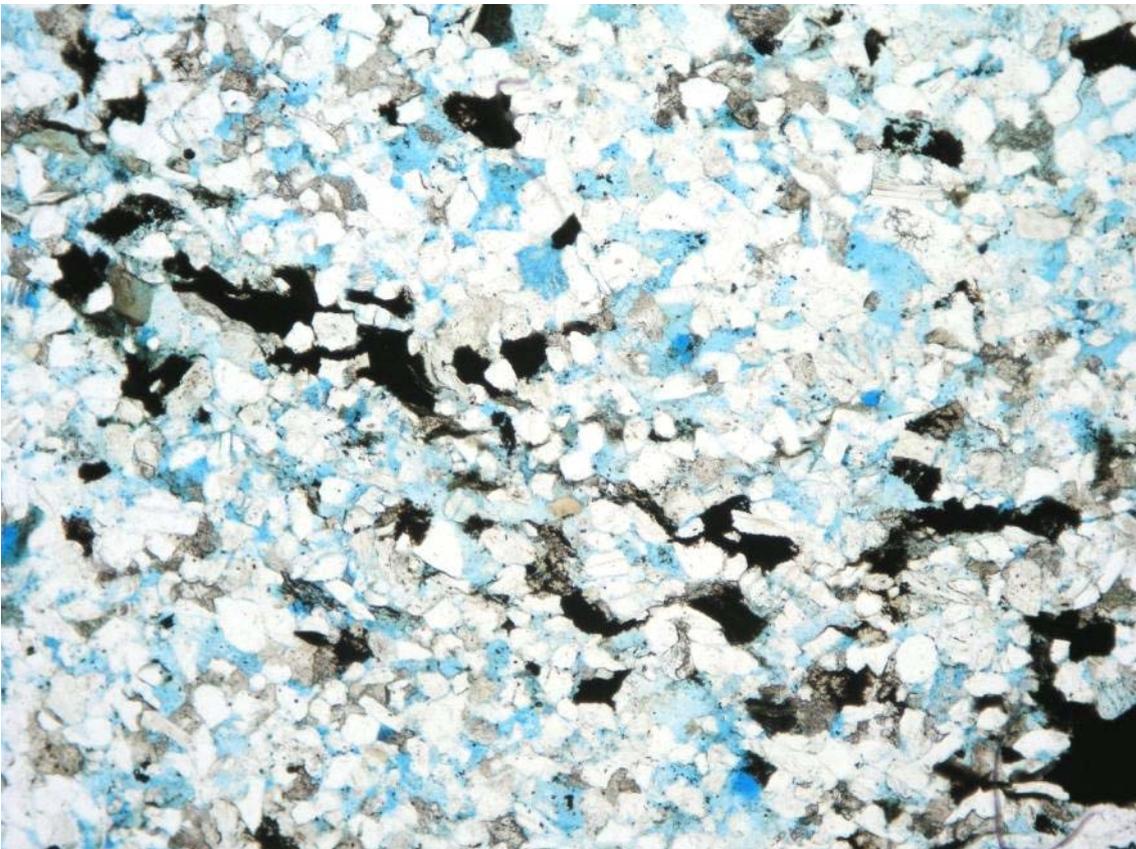
- 8) The fabric consists of parallel lamination with 'wispy' lamination in foreset packets.
- 9) Several percent of detrital feldspar and rock fragments have dissolved and are now clay minerals.

Figure A6_4. Two images of sample ED11052, as it appears in thin section. White grains are mainly quartz. Black areas are mainly iron oxide minerals. Brownish, mottled patches are carbonate mineral. Mottled bluish patches are clay mineral. Pore spaces appear clear blue. The field of view is 3.3 mm wide.

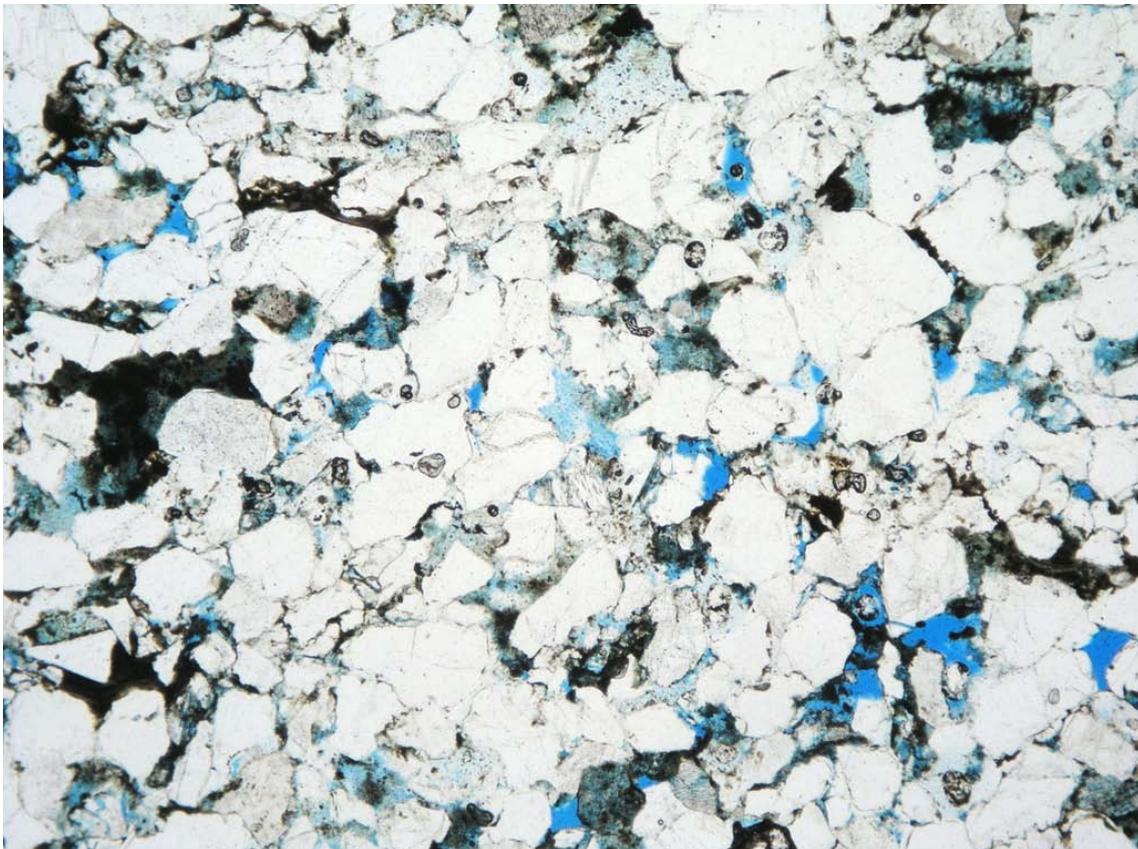
- 1) The sample is a fragment of the exterior dressed stone from ground level of The Steeple. The exterior surface is covered in a transparent coating, possibly to prevent water penetration.
- 2) Rounded zircons appear as an accessory mineral.
- 3) Mica flakes are both biotite and muscovite.
- 4) Porosity is relatively low (~9%) and pore spaces are poorly connected.

Figure A6_8. Two images of sample ED11054, as it appears in thin section. White grains are mainly quartz and off-white grains are mainly rock fragments. Black areas are mainly iron oxide minerals. Mottled bluish areas are clay mineral. Pore spaces are clear blue. The field of view is 3.3 mm wide.
