A survey of building stone and roofing slate in Falkirk town centre

Open Report OR/13/015

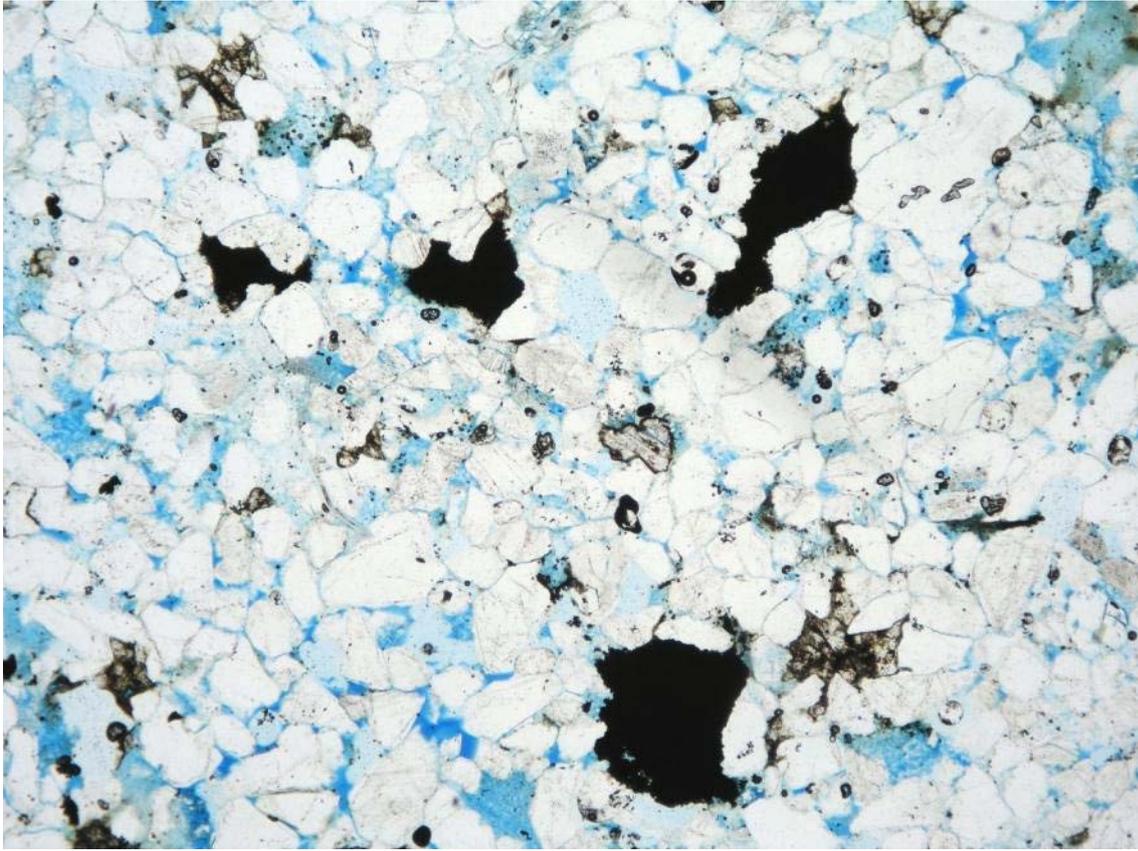
- 1) The sample consists of a chip from a window jamb at first floor level.
- 2) The exterior surface is weathered to a depth of less than 1 mm, and is greyish buff.
- 3) A strongly speckled character is given by dark reddish brown spots of iron oxide.
- 4) Flakes of muscovite mica are relatively common and aligned, marking the bedding orientation.
- 5) The carbonate mineral is iron-rich (ferroan dolomite, ankerite or siderite).
- 6) There are occasional fragments of carbonaceous matter.
- 7) Clay minerals in the intergranular pore spaces are in large part the result of dissolution of feldspar grains and rock fragments.

Figure A6_11. Two images of sample ED11061, as it appears in thin section. White grains are mainly quartz. Black areas are mainly iron oxide minerals, which can form laminae (as in the lower image). Light grey, mottled patches are carbonate mineral. Mottled bluish areas are clay mineral. Pore spaces are clear blue. The field of view is 3.3 mm wide.

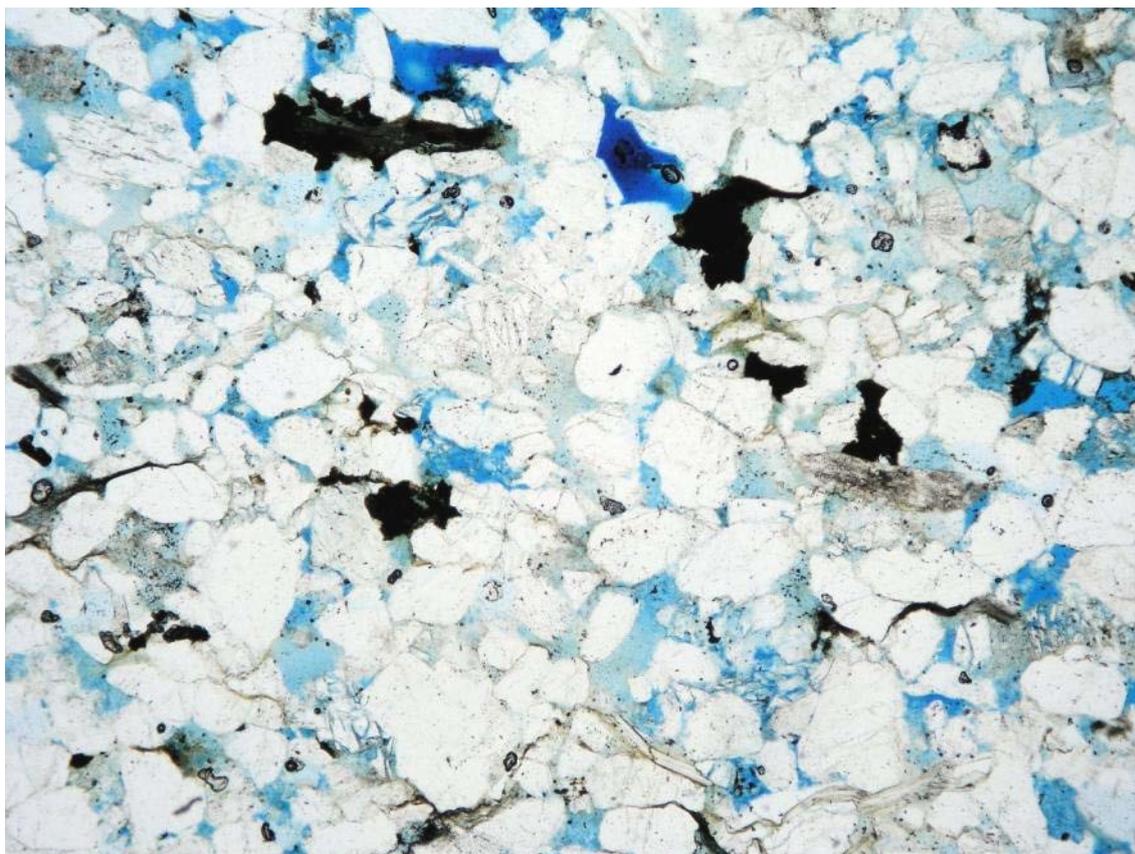
- 1) The sample is a small chip from a quoin at the top of the first floor level.
- 2) The faint laminae consist of concentrations of iron oxide minerals and mica flakes.
- 3) Rounded grains of tourmaline and zircon appear as accessory minerals.
- 4) Most of the clay mineral content is probably due to alteration of feldspar grains and rock fragments.

Figure A6_12. Two images of sample ED11062, as it appears in thin section. White grains are mainly quartz. Black areas are mainly iron oxide minerals, which can form laminae (as in the lower image). Mottled bluish areas are clay mineral. Pore spaces are clear blue. The field of view is 3.3 mm wide.
